**RFP# 4258 - Addendum #1
Roof Replacement
Ross Road School**

Re: Asbestos and PCB Test Results – Ross Road School
336 Ross Road, Westphal, Nova Scotia
Pinchin File: 348252

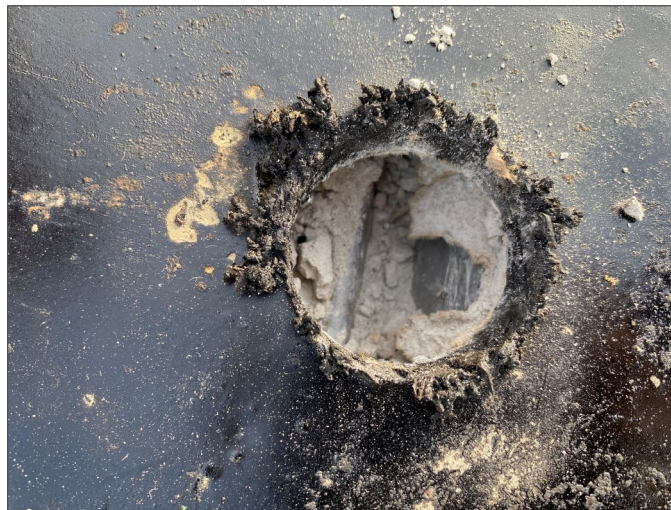
Sample No.	Location	Description	Result (Type and %)
S0001A-C	Gym Roof (Location 1)	Roofing Material (Cores)	None Detected
S0002A-C	Gym Roof (Location 1)	Black Mastic, present on exhaust ducts	Asbestos Detected (Chrysotile, 5-10%)

Photo 2 - S0001A-C (None detected) Roof core

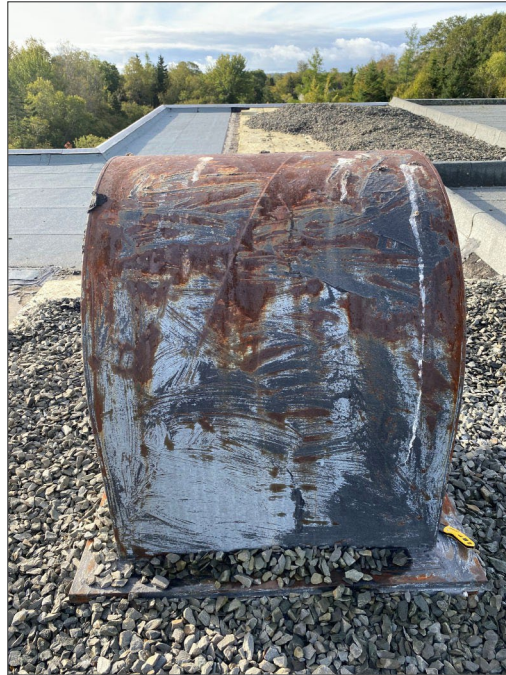
SAMPLE IDENTIFICATION	SAMPLE DESCRIPTION	% COMPOSITION (VISUAL ESTIMATE)	
		ASBESTOS	OTHER
S0002A Duct, Exhaust, Mastic, Black, Loc:1, Gym Roof	Homogeneous, black, tar material.	Chrysotile 5-10%	Mica 0.5-5% Tar and other Non-Fibrous Material > 75%
S0002B Duct, Exhaust, Mastic, Black, Loc:1, Gym Roof			Not Analyzed
Comments:	Analysis was stopped due to a previous positive result.		
S0002C Duct, Exhaust, Mastic, Black, Loc:1, Gym Roof			Not Analyzed
Comments:	Analysis was stopped due to a previous positive result.

Photo 3 - S0002A-C, Confirmed Asbestos, Black duct mastic

Remove and properly dispose of asbestos-containing materials prior to disturbance. Follow appropriate safe work procedures when handling or disturbing asbestos. The specific work procedures, engineering controls and personal protective equipment (risk level) will need to be assessed on a project-by-project basis.

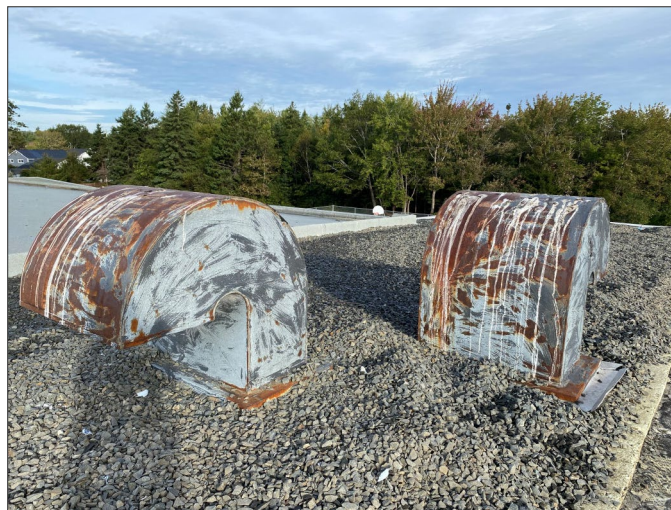
Photo 4 - Two exhaust ducts with asbestos-containing black mastic

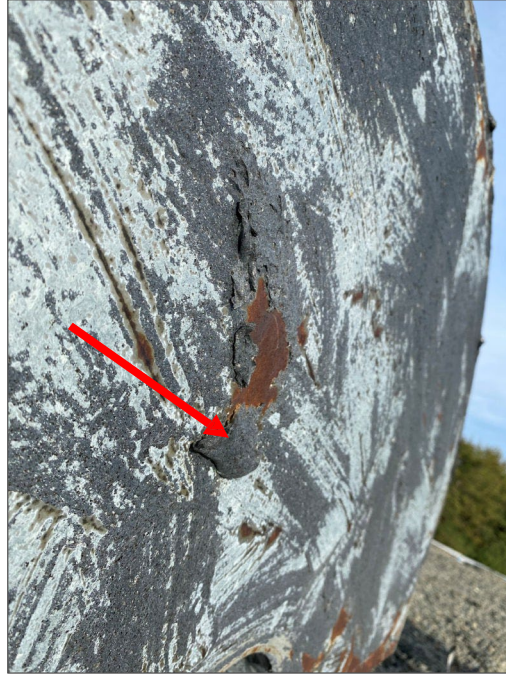
Photo 5 - S0002A-C, Confirmed asbestos, Black mastic
